Best Practices and Lessons Learned from 25 Years of PCB Assessment and Remediation on the Waterfront

Presented by: Kevin T. Russell Collaborators: Clay Patmont, Jim Redwine

April 11, 2024

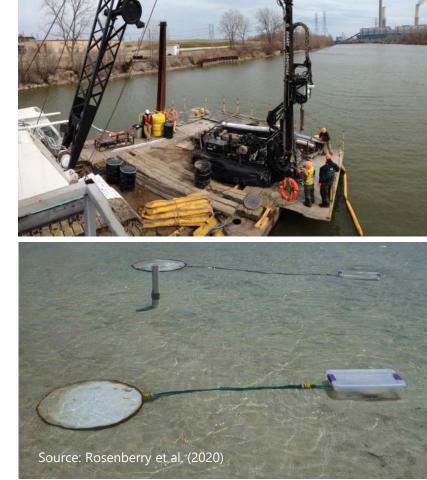
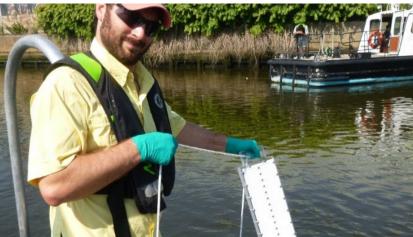
- Multi-media approach is almost always needed; some require specialized sampling techniques
  - PCB sampling media
    - Soil, sediment, porewater
    - Surface water
    - Biota (e.g., fish tissue)
  - Other types of data collection
    - Surface water elevations, flows, velocities
    - Groundwater/surface water interactions
    - Sediment deposition and erosion

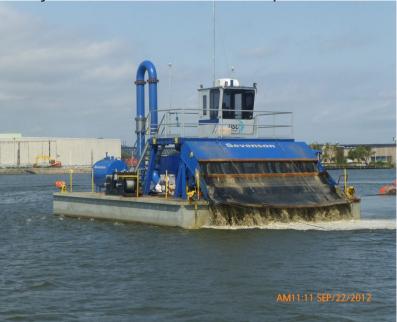
Hydraulic Placement of Cap Material

- Numerous technologies, but most often three main approaches
  - Removal (dredging)
  - Containment (capping, including with amendments)
  - Monitored natural recovery (MNR)

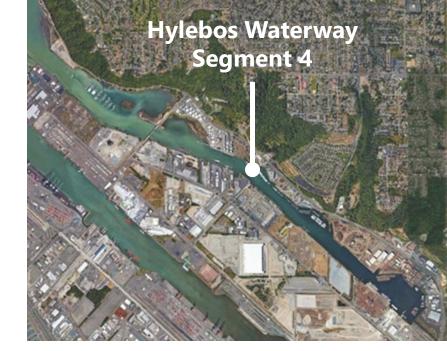
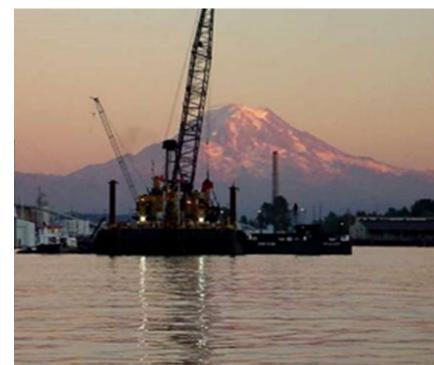
#### Hylebos Waterway, Washington

- Part of Commencement Bay Site
- Numerous historical PCB sources
  - Extensive wastewater/stormwater controls and upland/shoreline cleanup actions: 1985 to 1999
  - Source control verified in 2001
- Sediment remediation: 2001 to 2006
  - 24 acres dredged (1,500,000 cy)
  - 8 acres monitored natural recovery
  - 3 acres capped

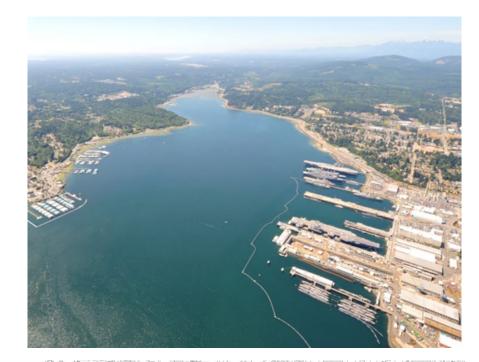
## Sinclair Inlet, Washington

- Numerous historical shipyard PCB sources
  - Continuous process improvements and upland cleanup actions beginning in 1992
- Navigation dredging in 1994/1995
- Navigation/Superfund actions in 2000/2001
  - 32 acres dredged (225,000 cy)
  - 13 acres capped or sand covered
- Shipyard infrastructure projects in 2011
- Fish tissue sampling: 1991 to 2017
