# Discovering and Treating PFAS while Decommissioning a Power Plant

**Tom Boom**  
May 22, 2025

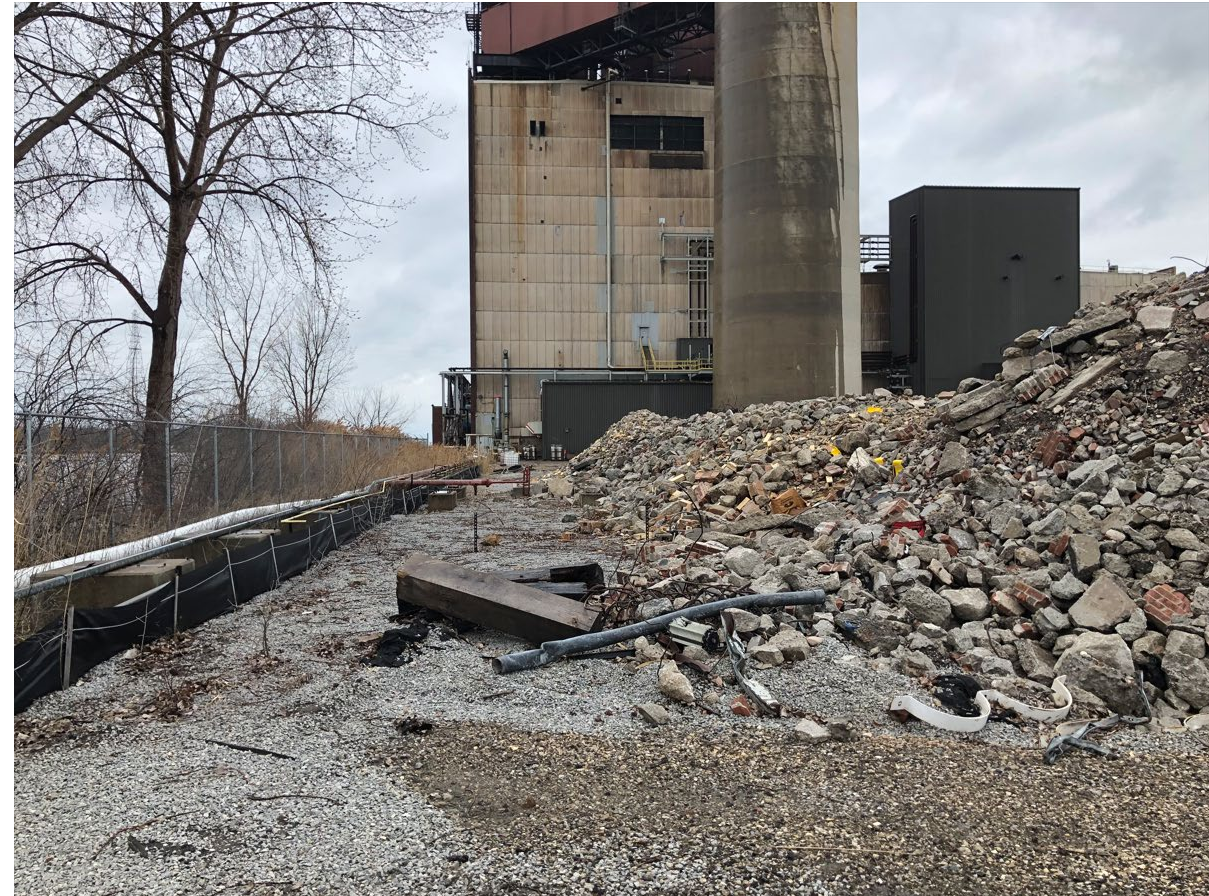
- Power plant in process of being decommissioned
- Basement elevation 10-12' lower than nearby major water body
- Water needed to be removed from basement during decommissioning
- Discovered PFAS in basement water while sampling
- Source of PFAS unknown, but water needed to be removed during decommissioning (anticipated 2-3 months), and needed to be treated
- Fast turn, because decommissioning was occurring

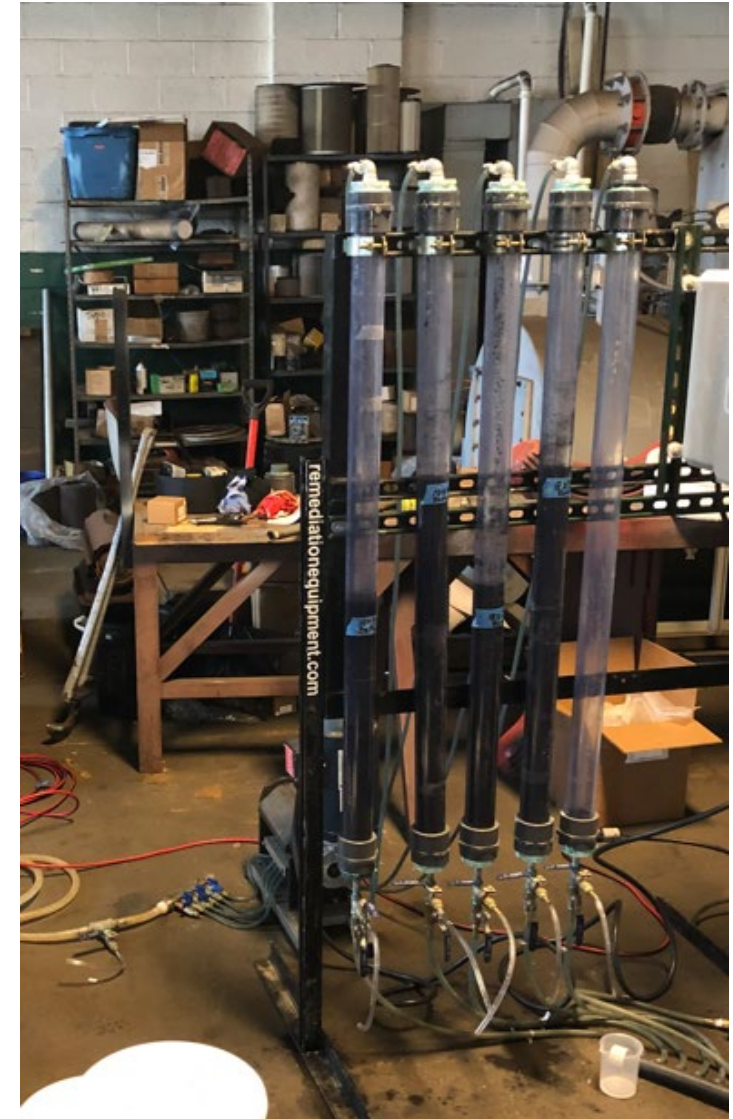
- Barr evaluated multiple options for PFAS:
  - Ion exchange
  - Foam fractionation
  - Reverse osmosis
  - Carbon
- Since carbon was most likely given the timeframe, contacted a vendor to conduct bench study while we evaluated further
- Geochemical modeling for pH: bench testing of aeration
- Carbon treatment bench study errors

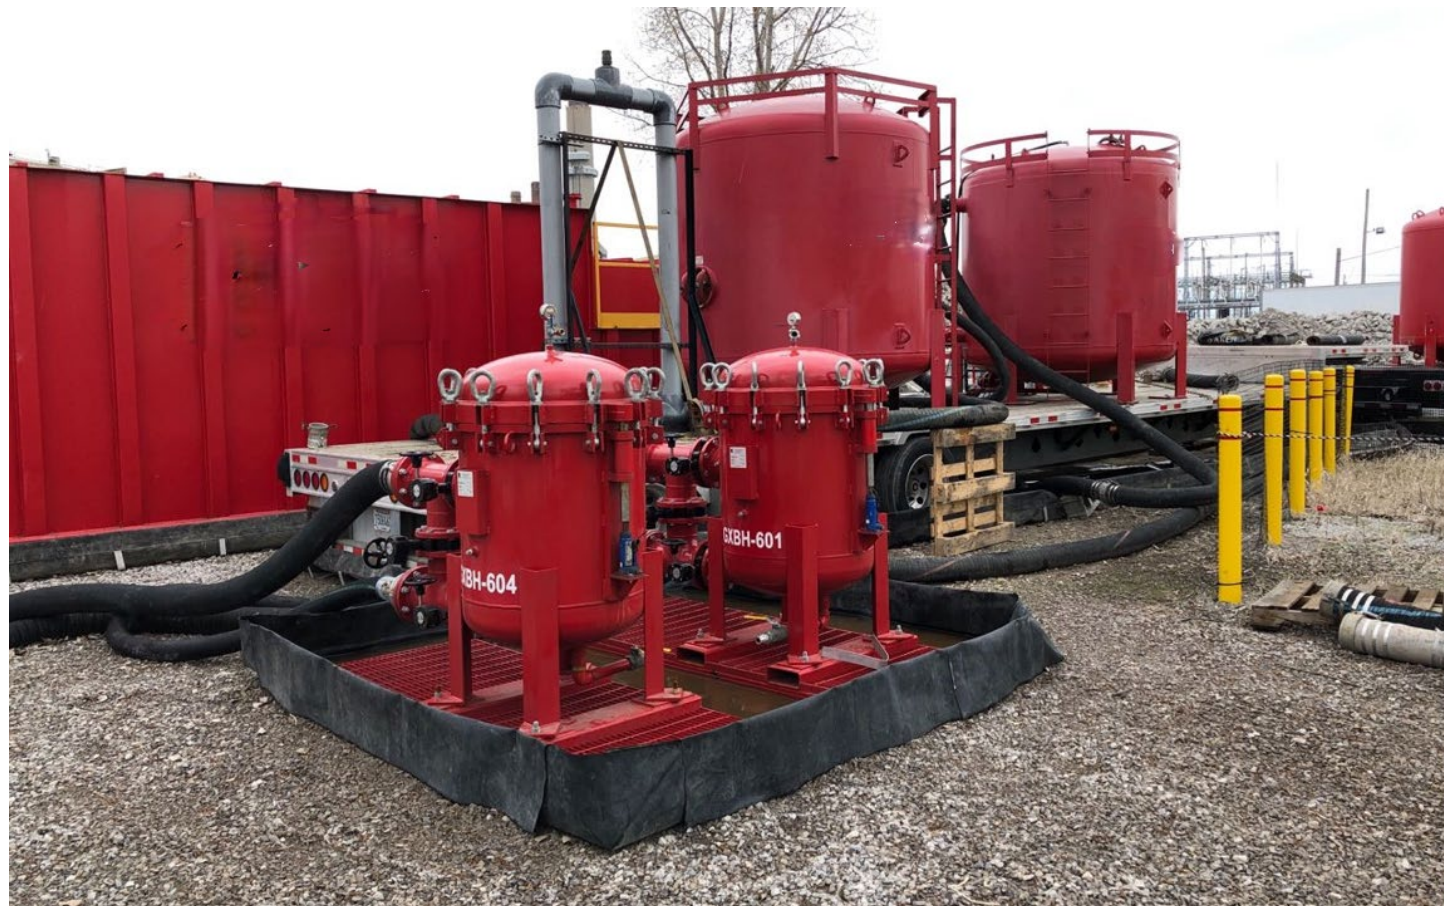
# Changing Conditions During Decommissioning – Particulates

- Very high TSS – 30% of basement backfilled
- Included concrete dust
- Bag filters changeouts very frequent

- Moved frac tanks to beginning of treatment train to act as settling tank
- Added second bag filter – 25 um and 10 um

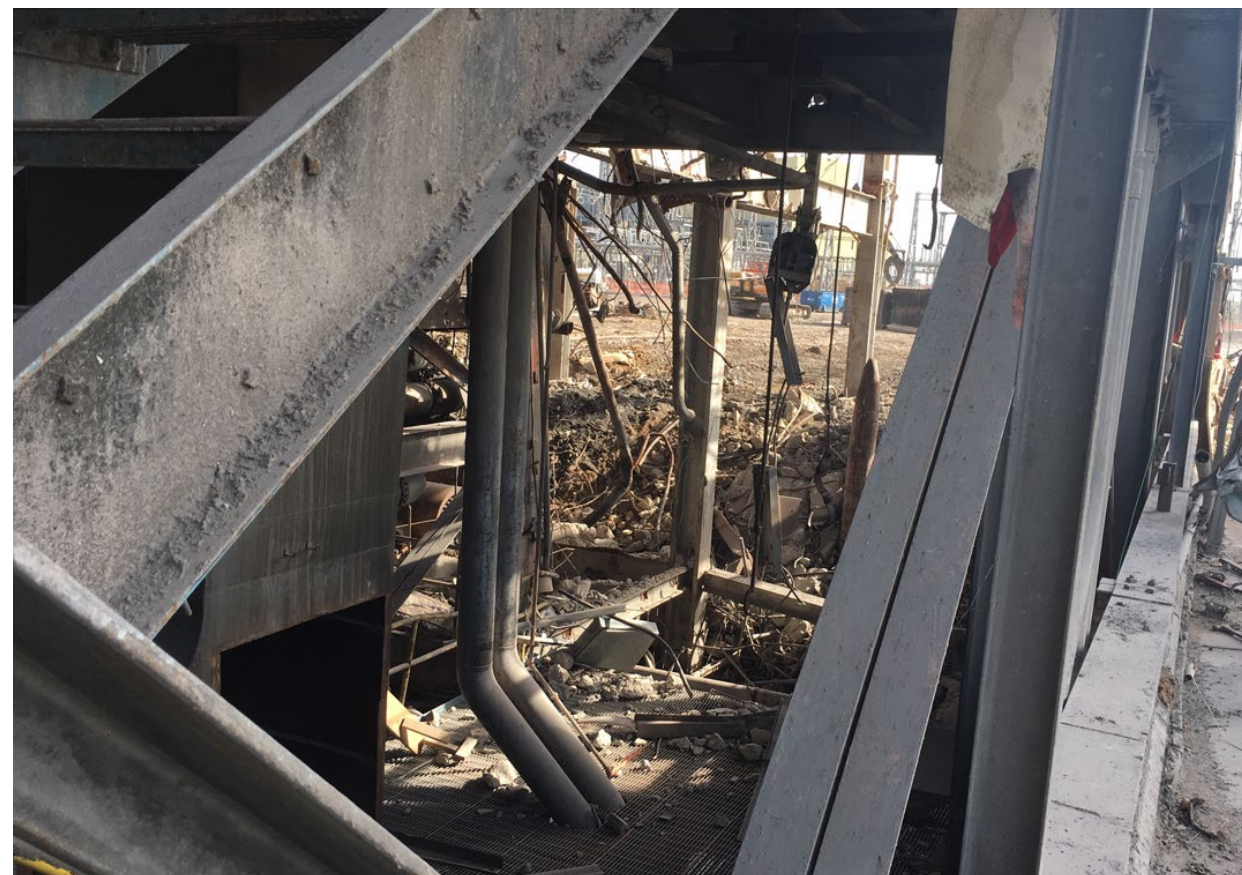
- Basement backfilling included concrete and concrete dust
- pH above 12 within a month
- Treatment no longer possible with aeration
- Acid addition not possible due to regulatory requirements

- Evaluate other options

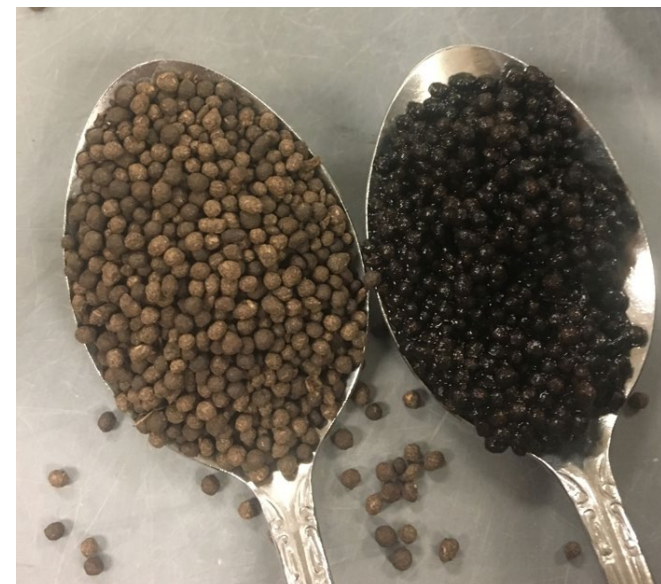
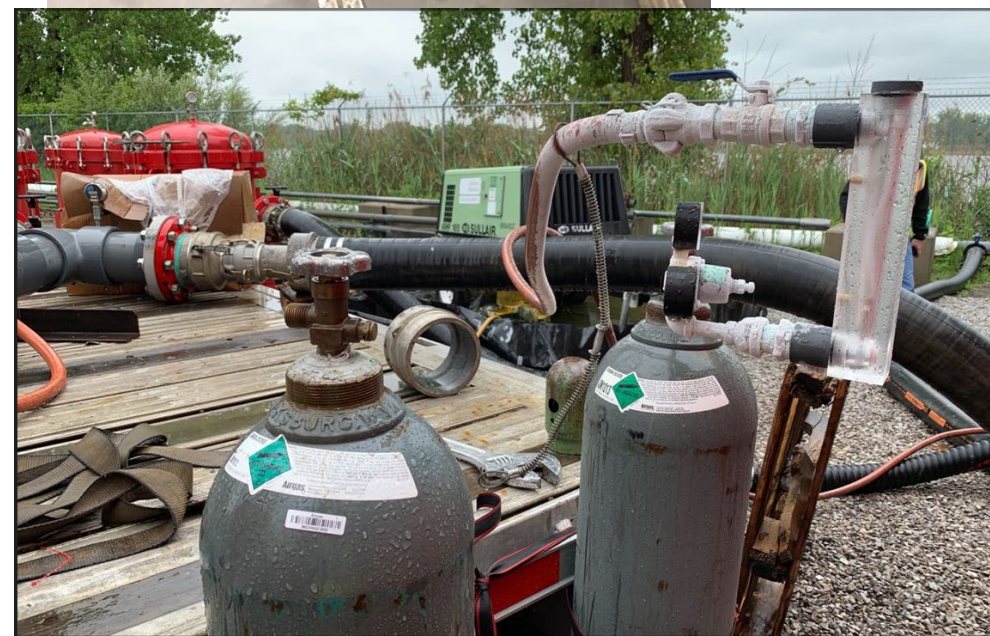
- Passive (peat moss)
  - Use in either in line treatment or placed into basement water
  - Bench tests showed pH reduction achievable
  - 20 cy peat could treat 140,000 gallons of water
  - 75 tons of peat placed in basement would reduce pH by 1 standard unit
- Active (carbon dioxide)
  - Tested in full scale system and it worked well
  - Switched to fine bubble diffusers

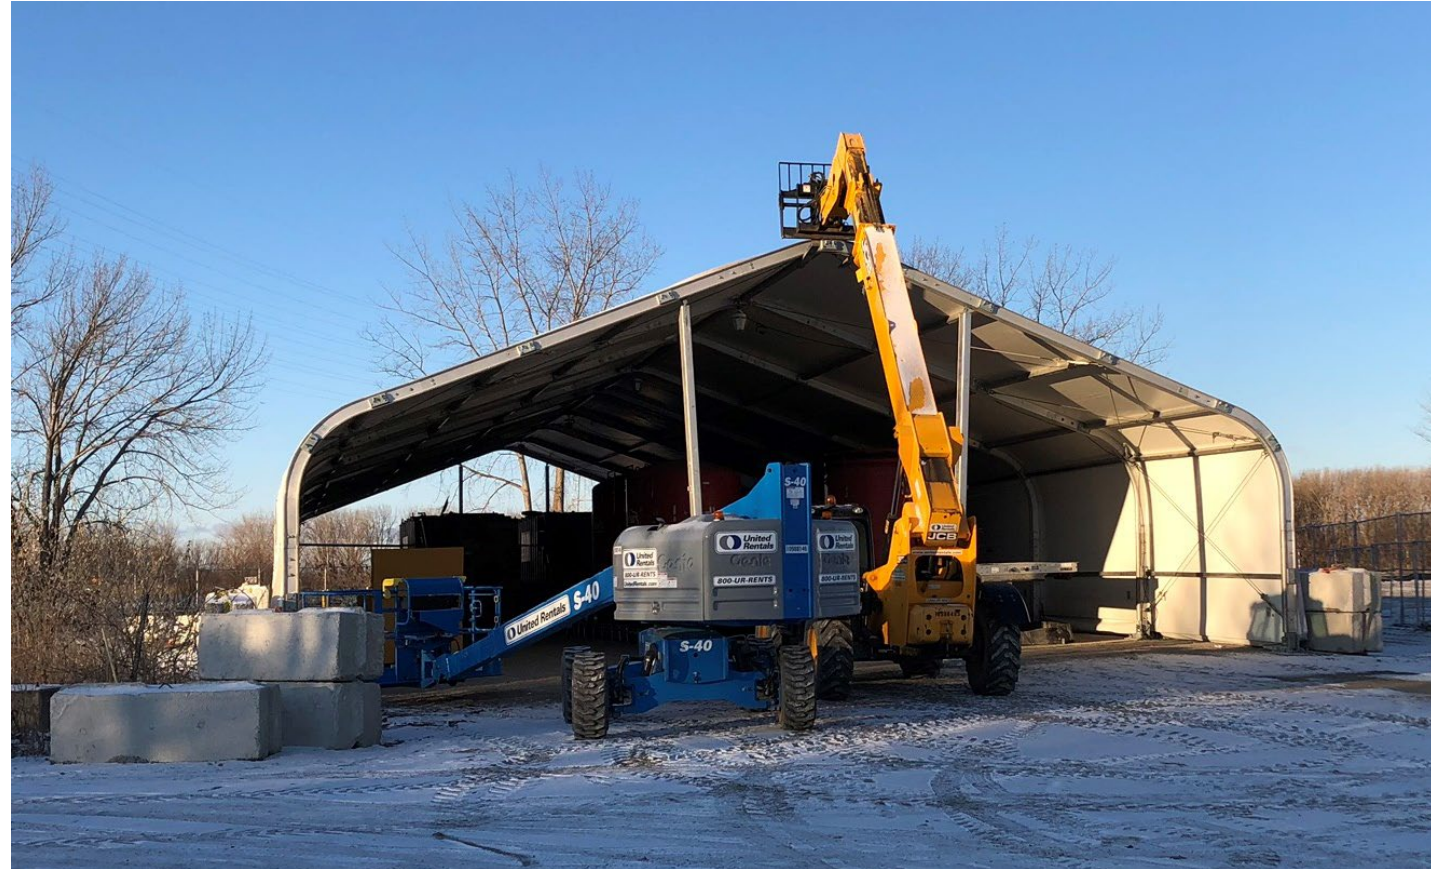
# Changing Conditions During Decommissioning – Extended Duration

- Initial timeframe planned for 2-3 months in summer
- Decommissioning delays
- Extended into winter

- Winterize system
- Construct structure

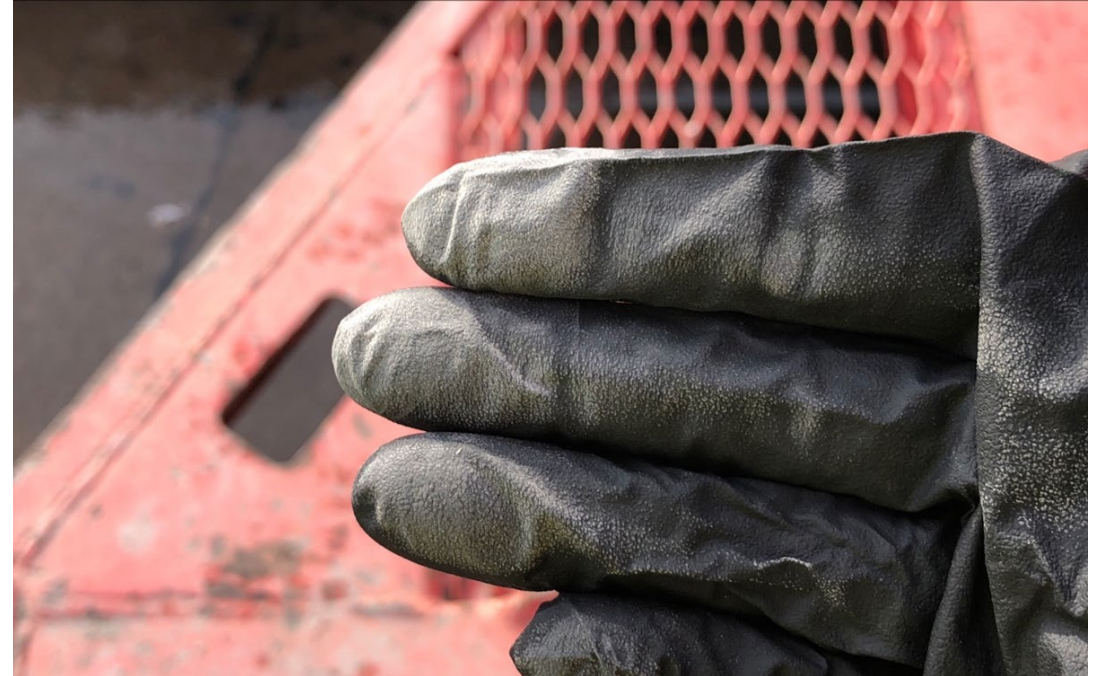
- Breach of containment
- Asbestos water flowed into Sump 1 and pumped into treatment system
- Asbestos testing and carbon replacement
- Frac tank cleaning

- Scaling from caustic environment and particulates
- 10,000 psi power washer
- Mobile treatment system
